NASA TN D-3068

EVALUATION OF A SUBSCALE INTERNALLY INSULATED FIBER-GLASS PROPELLANT TANK FOR LIQUID HYDROGEN

by Laurence J. Heidelberg

Lewis Research Center
Cleveland, Ohio

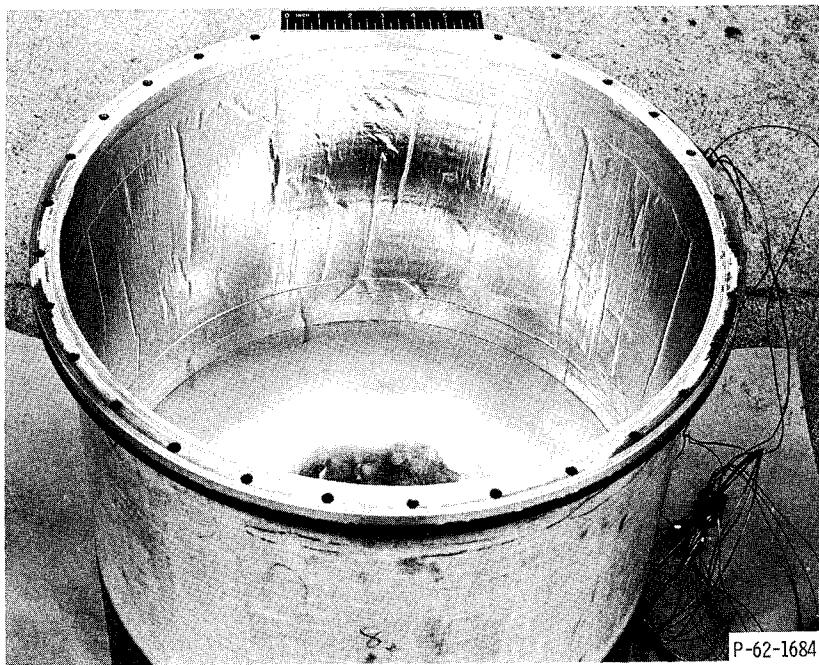
Figure 10. - Uninsulated filament-wound tank with test liner wrinkles after two temperature and pressure cycles.

Prior to fabrication of the test tank, uninsulated but lined filament-wound tanks, similar in geometry to the test tank, were pressure cycled with liquid hydrogen in a vacuum chamber to check the reliability of the adhesive joints with respect to maintaining a seal. The liner shown in figure 10 has gone through two temperature and pressure cycles. After some initial failures a reliable leak-tight adhesive bond was achieved. However, it was decided that some method of reducing the size of the wrinkles in the liner must be found or the resulting sharp creases formed upon repressurization would cause leaks or even breaks. If the liner material is stressed beyond its elastic limit, subsequent loadings to a lower stress produce no further permanent set. This can be seen in figure 8 where the AMA laminate was first stressed to 8300 pounds per square inch and then cycled from 0 to 6250 pounds per square inch six times. It was decided to fabricate the liner and vacuum jackets from 25-pound-per-inch-load (10,040 psi) prestretched AMA laminate to keep the permanent set and, therefore, the wrinkles to a minimum. Figure 9 shows a cycling test of this prestretched material at a temperature of -300° F and a strain of 0.015 inch per inch. It should be noted that most of the strain is within the elastic range. Even with this prestressed material some permanent set was expected when it was used in the test tank. But, it was felt that the bond between the foam insulation and the inner vacuum jacket would stabilize the wrinkles that would occur thus preventing the formation of sharp creases.

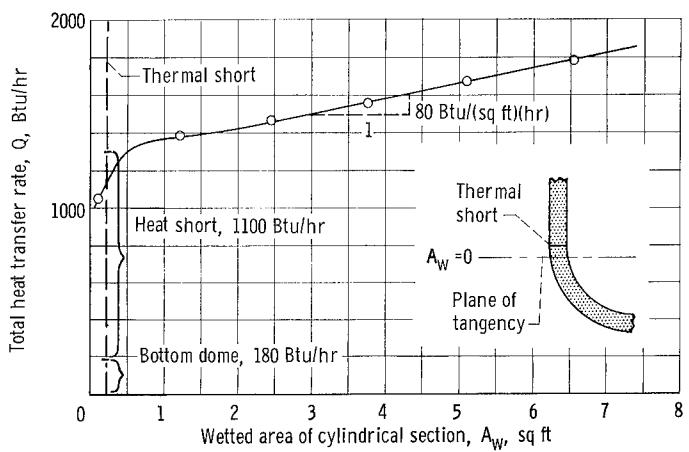
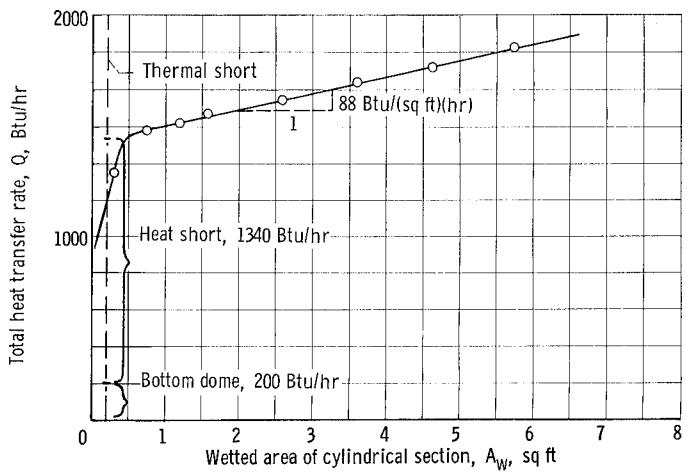
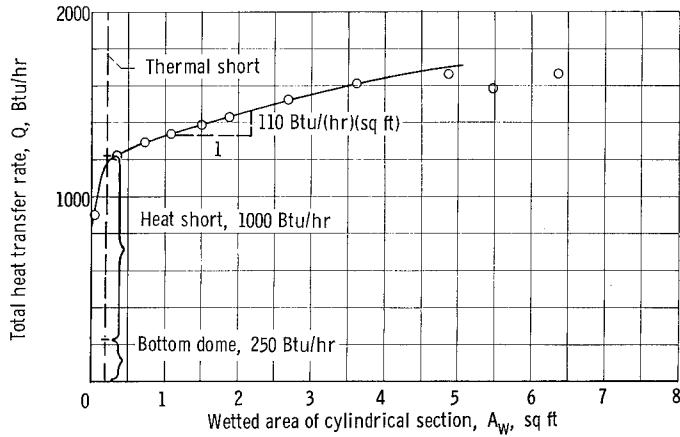
As shown in figures 14, 15, and 16, there is a large heat short at the intersection of the bottom dome and the cylindrical section of the insulation. This heat short is caused by the heavy AMA laminate used on the edge of each insulation section (see fig. 1(d), p. 5). The heat short was calculated to be 1050 Btu per hour, while the value, determined by extrapolating the curve (see figs. 14 to 16) and assuming the heat flux through the bottom dome the same as in the cylindrical section, varied from 1000 to 1340 Btu per hour, depending on ambient conditions. At 75 percent of tank capacity more than 50 percent of the heat transfer was due to this heat short. Calculations show that if Mylar were used instead of the AMA laminate to seal the edges of the insulation sections, the heat short to the liquid would be reduced to approximately 1 Btu per hour.

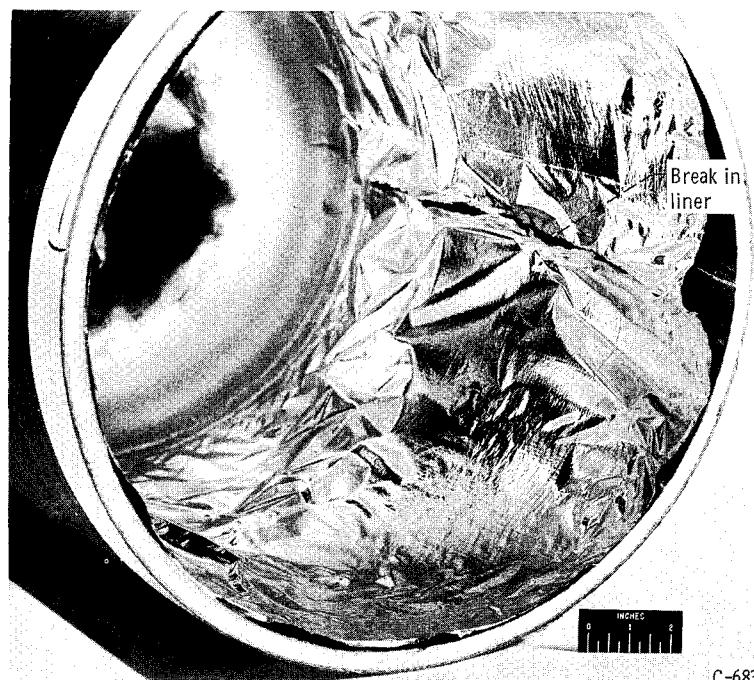
Figure 17. - Inside of tank (showing failure in liner).

Liner failure occurred suddenly with a longitudinal break in the cylindrical section of the tank (see fig. 17). Figure 18 shows the brittle fracture of the Mylar in the liner. Both the liner and the inner vacuum jacket failed at the same place. It should be noted that, even though the liner was highly stressed, all adhesive joints remained leak-tight. Upon examination of the inner vacuum jacket it was discovered that the break occurred along the butt joint of the glass-cloth bleeder ply (see fig. 19). Since the glass-cloth reinforced the vacuum jacket everywhere but at the butt joint where the cloth ends were not spliced, this was the area of highest stress. Instead of the inner vacuum jacket uniformly straining along the entire circumference, most of the expansion occurred over the very small length of this maximum stress area. Thus, the local unit strain was many times higher than it would have been for a uniformly strained material. It is probably the vacuum-jacket failure that initiated the failure in the liner at the same location. It is possible that this failure could have been prevented if the ends of the glass cloth were spliced at the butt joint with a bonded glass-cloth tape.

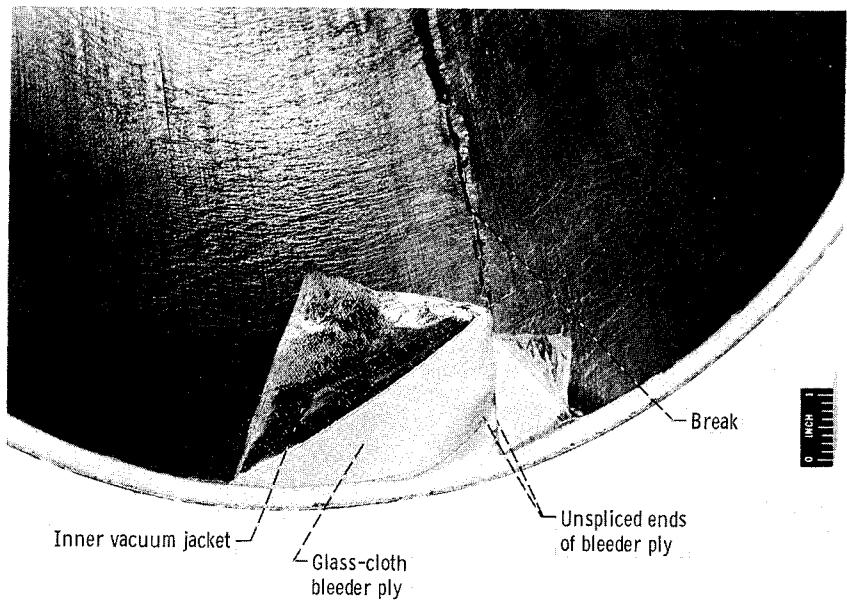
Figure 18. - Section of liner material at break.

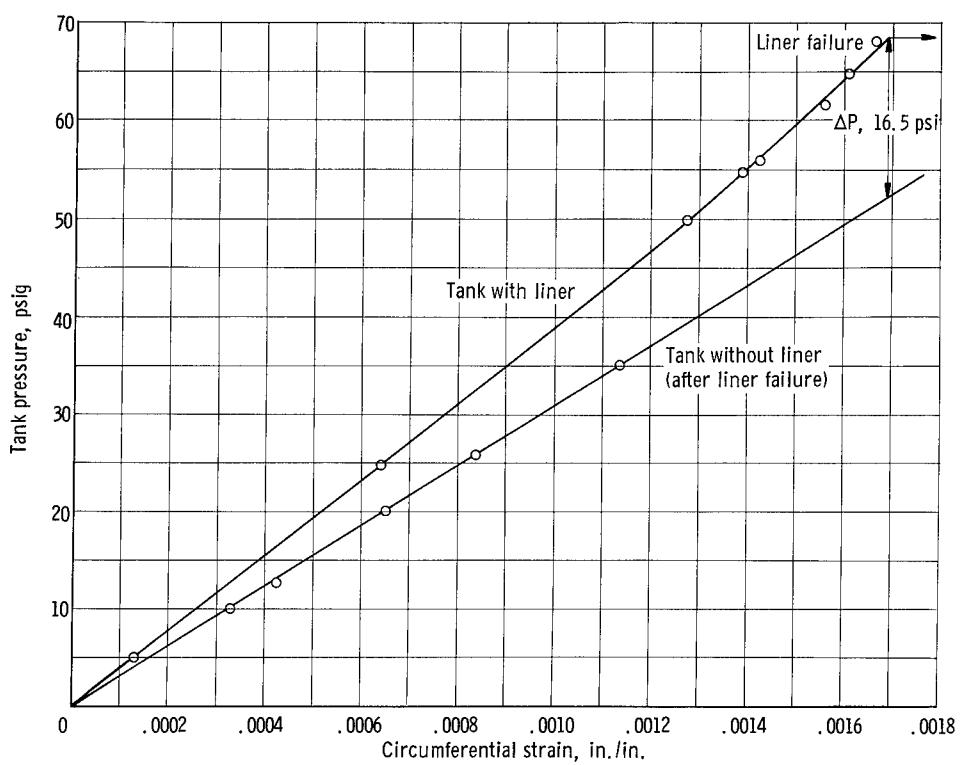
Figure 20. - Effect of liner failure on circumferential strain of tank wall.

The circumferential strain of the fiber-glass shell was measured during pressure tests of this tank both before and after liner failure. Figure 20 shows a plot of this strain against internal tank pressure. When failure occurred at 68.4 pounds per square inch gage, the release of the load carried by the liner and vacuum jacket resulted in increased load on a corresponding strain in the fiber-glass shell. Since the strain at failure, 0.0017 inch per inch, results from a load of only 51.9 pounds per square inch gage after failure, the difference between 68.4 and 51.9 pounds per square inch gage was assumed to be the load the liner and vacuum jacket were taking. Thus, the liner and jacket were taking an internal pressure load of 16.5 pounds per square inch and correspondingly stressed to 29 000 pounds per square inch at failure. This is an increase in tensile strength from the 25 000 pounds per square inch at -300° F listed in table I. The 51.9 pounds per square inch gage carried by the fiber-glass shell results in a composite wall stress of 12 000 pounds per square inch, well below its ultimate of 120 000 pounds per square inch.

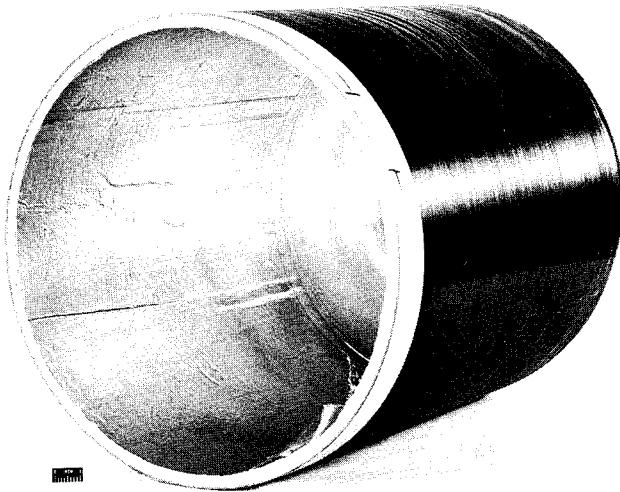
C-69087

Final examination of the tank revealed the existence of wrinkles indicating the liner and inner vacuum jacket material has been stressed beyond its elastic limit and thus has taken a permanent set in spite of prestressing the AMA laminate. It was found that the wrinkles in the vacuum jacket (see fig. 21) are not sharply creased as in the preliminary liner tests but rather they are rounded and not likely to be leak sources. It appears that the glass cloth and foam help stabilize the wrinkles and prevent the formation of sharp creases.

Figure 21. - Inner vacuum jacket after testing.
